The legacy of coal mining in Limburg

Coal mining and lagging effects of mining

Management of post mining risks, 'monitoring and control'

Delft, 15 nov. 2019
Ir. J.P.A.Roest

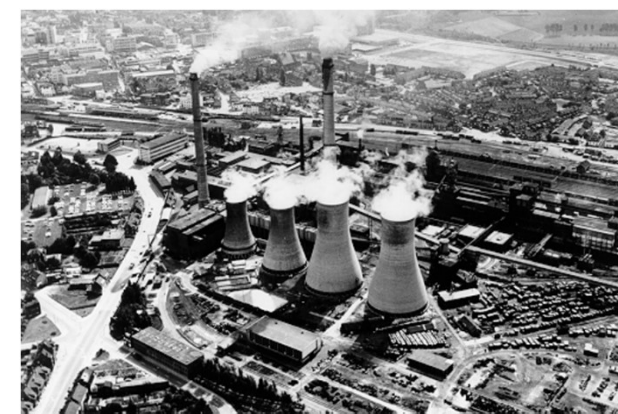
Domaniale 1847-1969

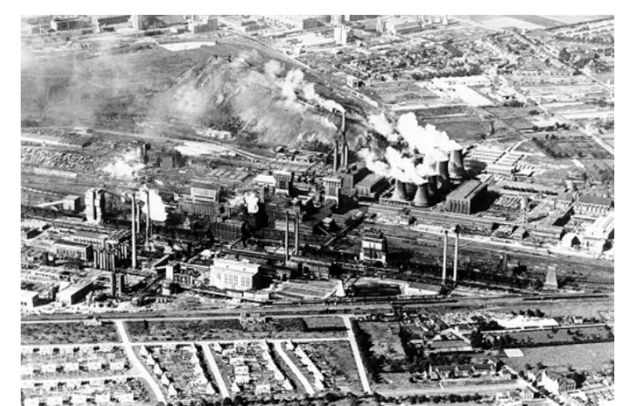
Oranje Nassau I 1899-1974

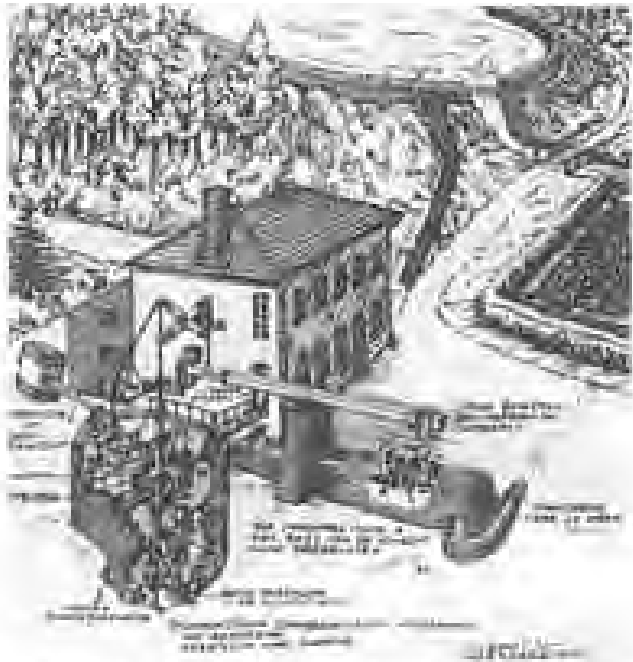
Maurits 1923-1967

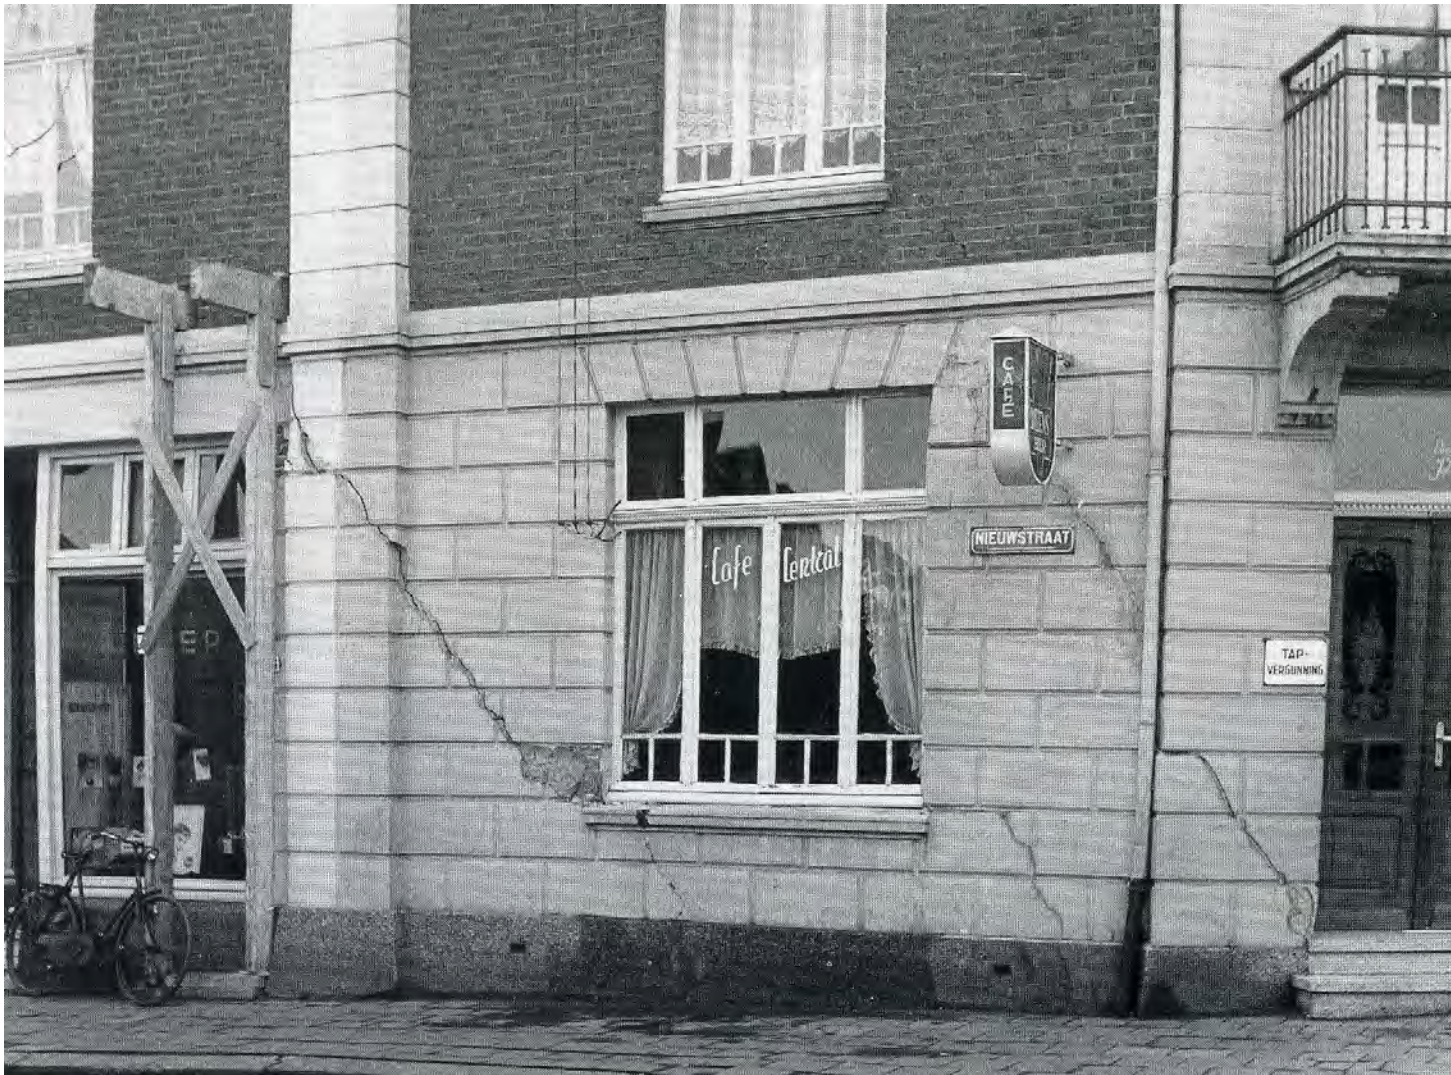
Example of damage due to coal production

Example of a surface step during coal production

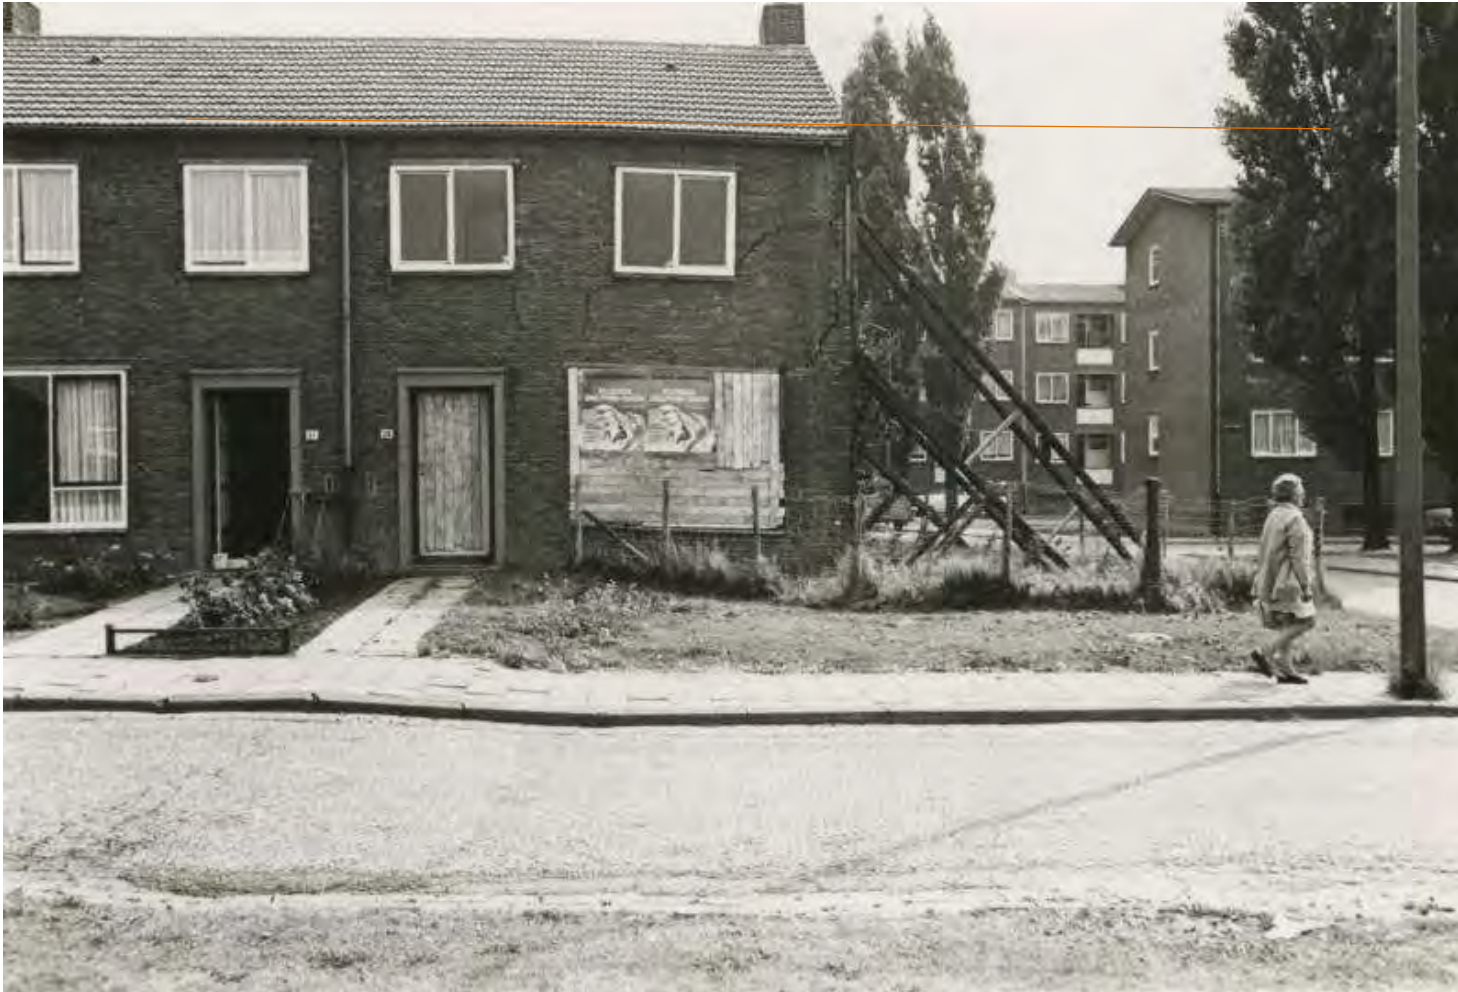
See roof and damage pattern

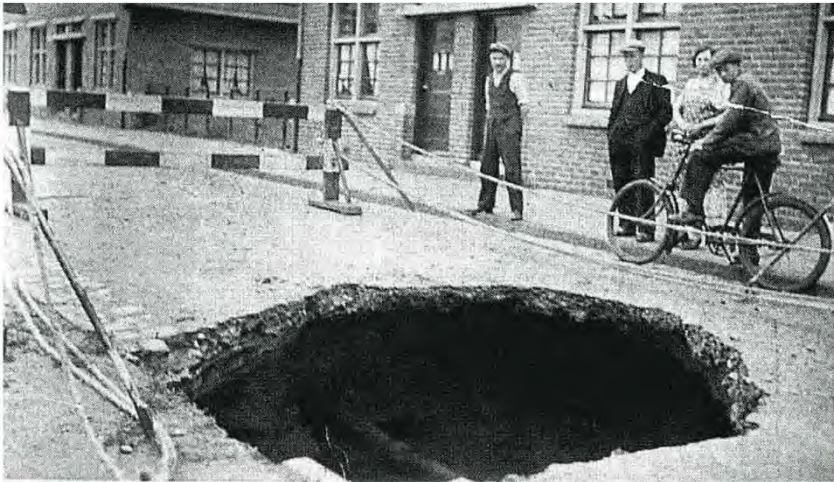
Example of a sinkhole

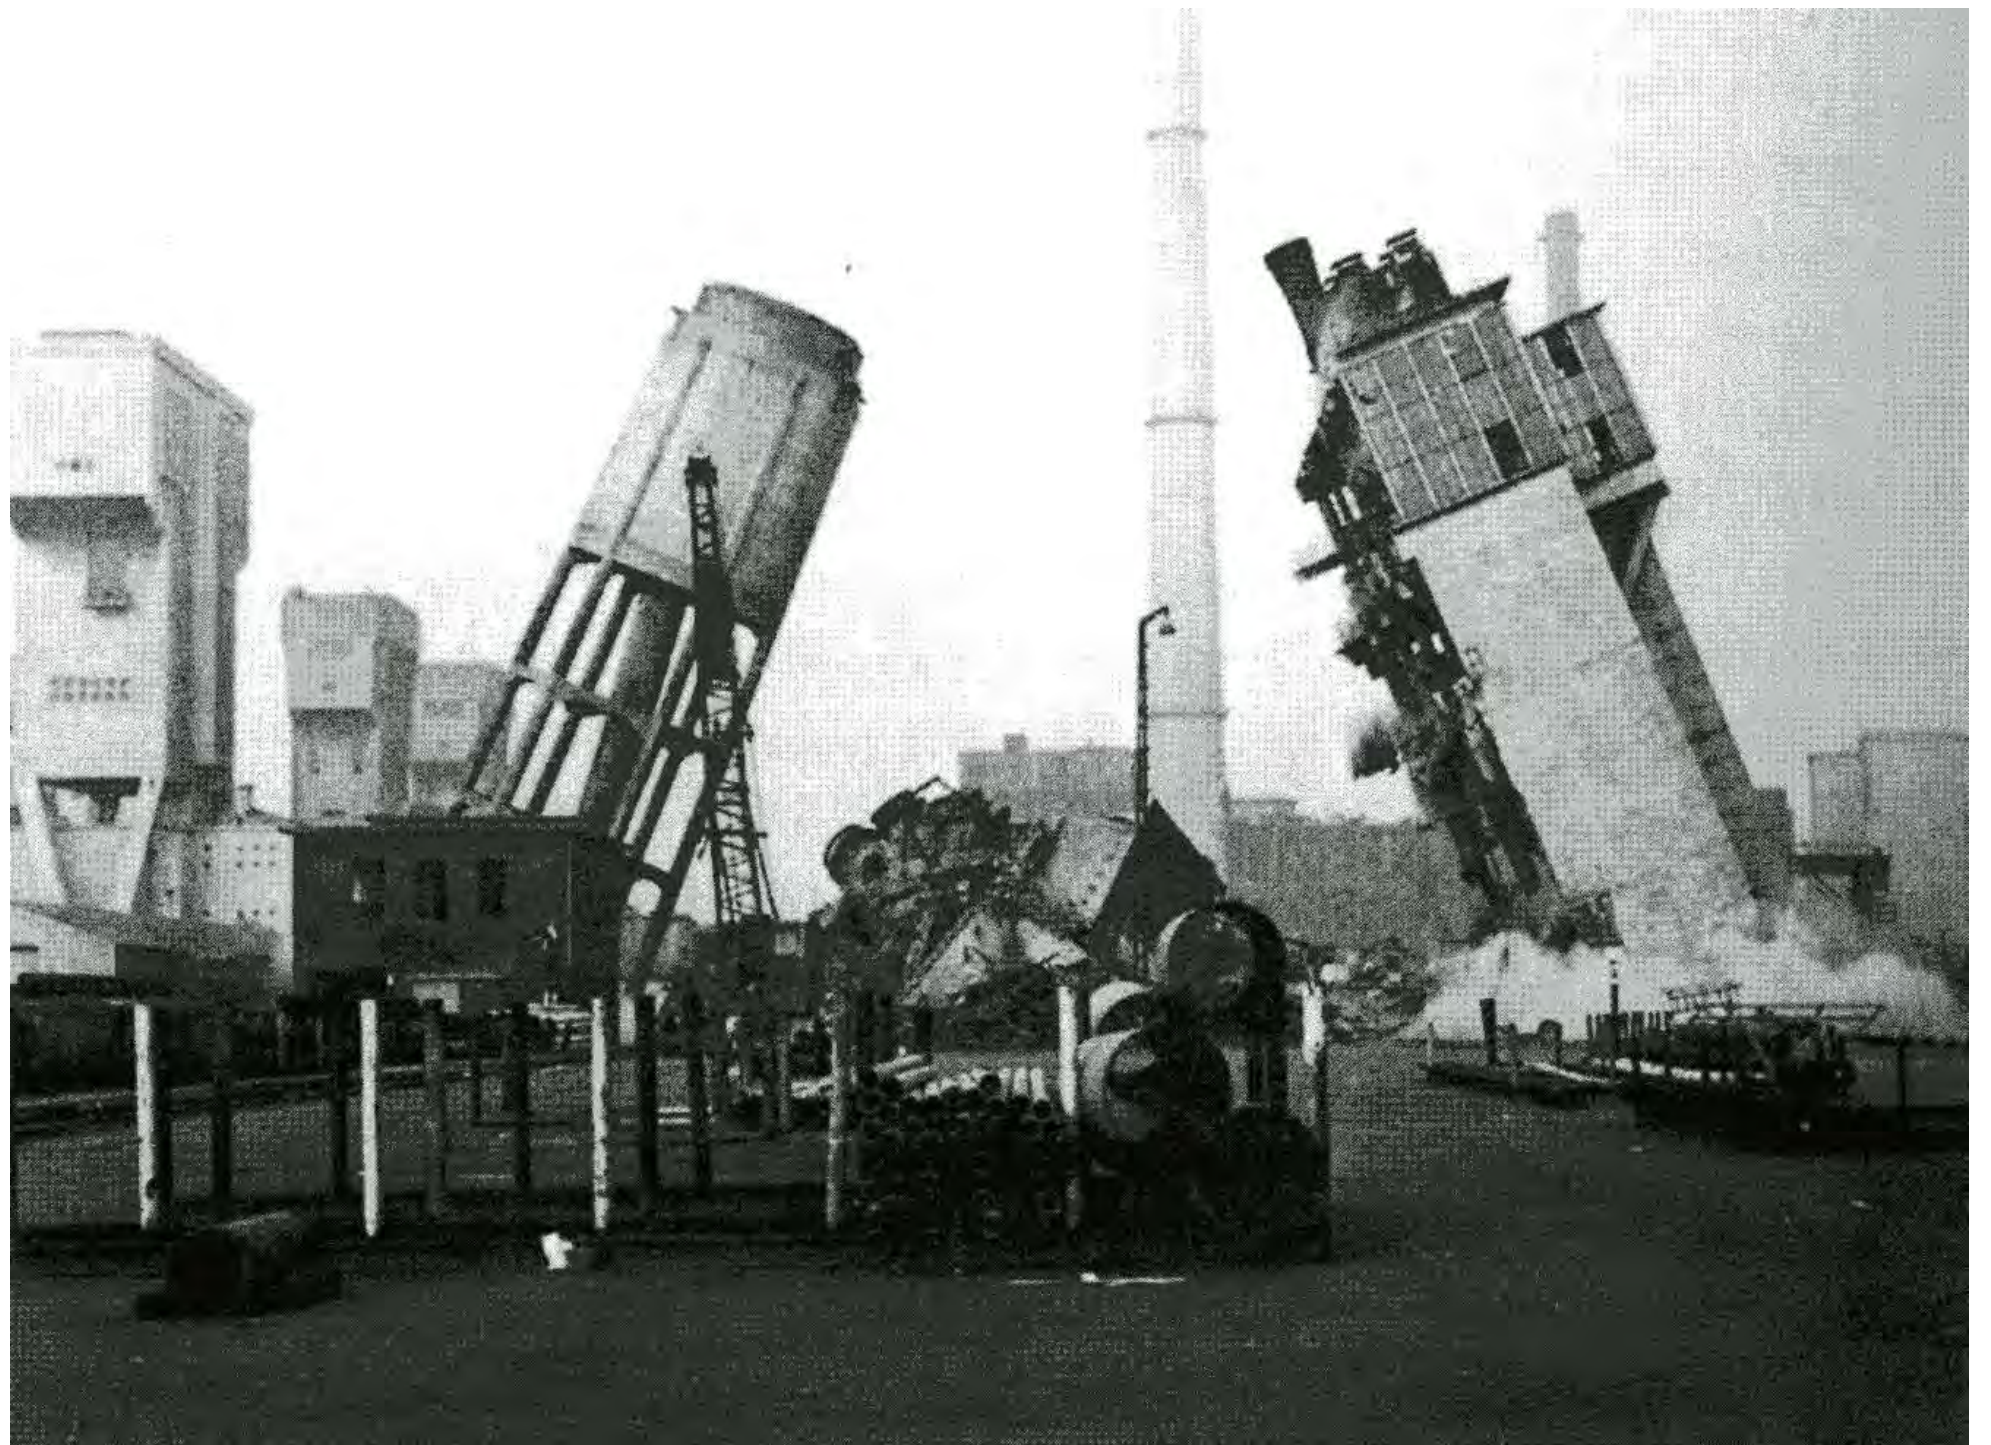
*From left to right: Fissure, Step fracture and Stairs fracture
(Spielberg, 1985)*

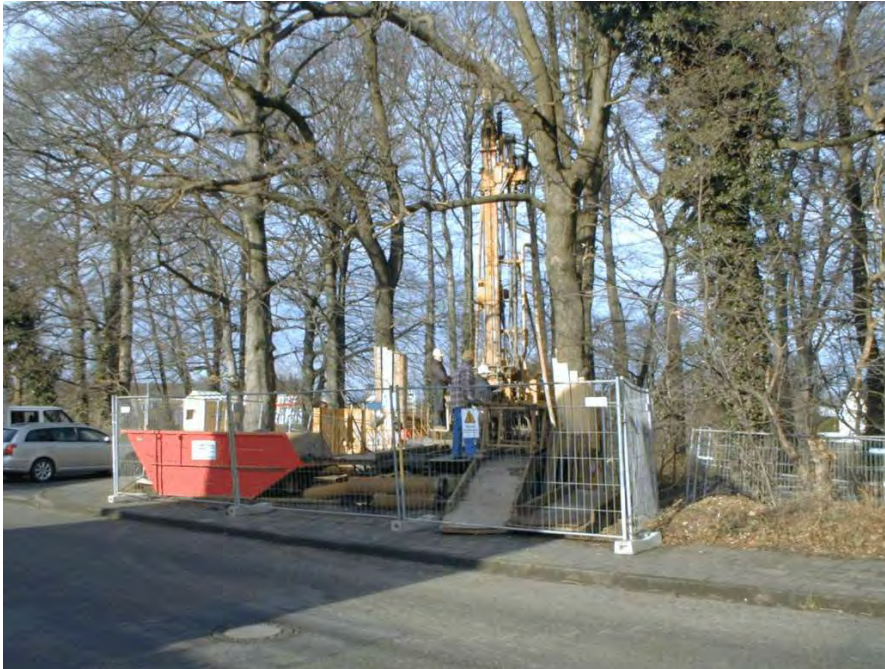
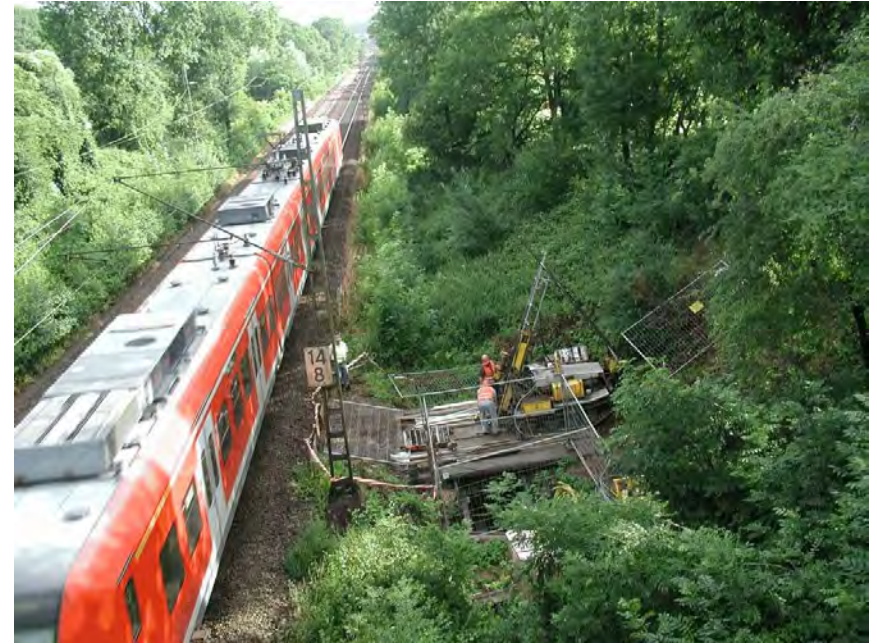
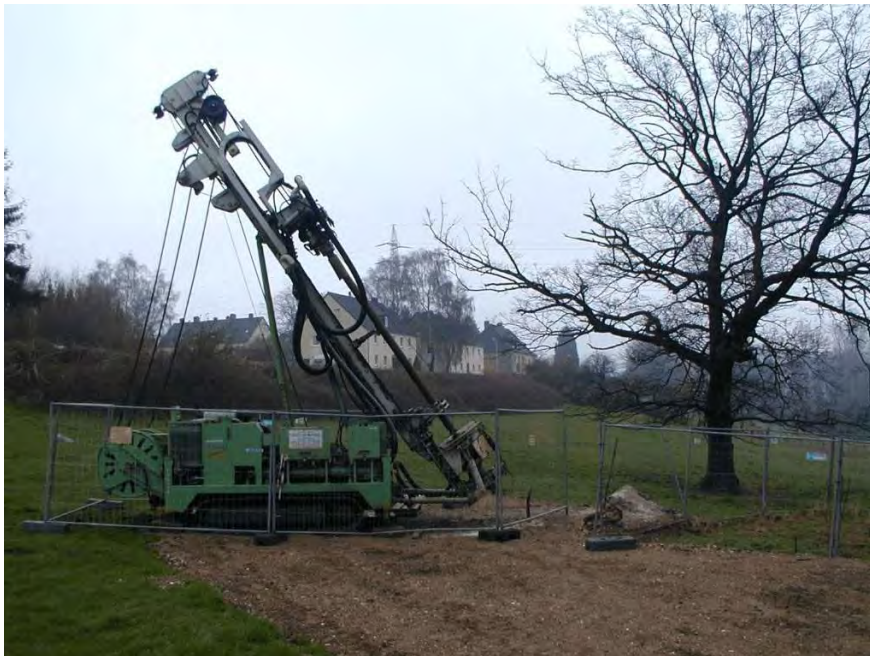
Remediation shafts in Germany (Domaniale mine)

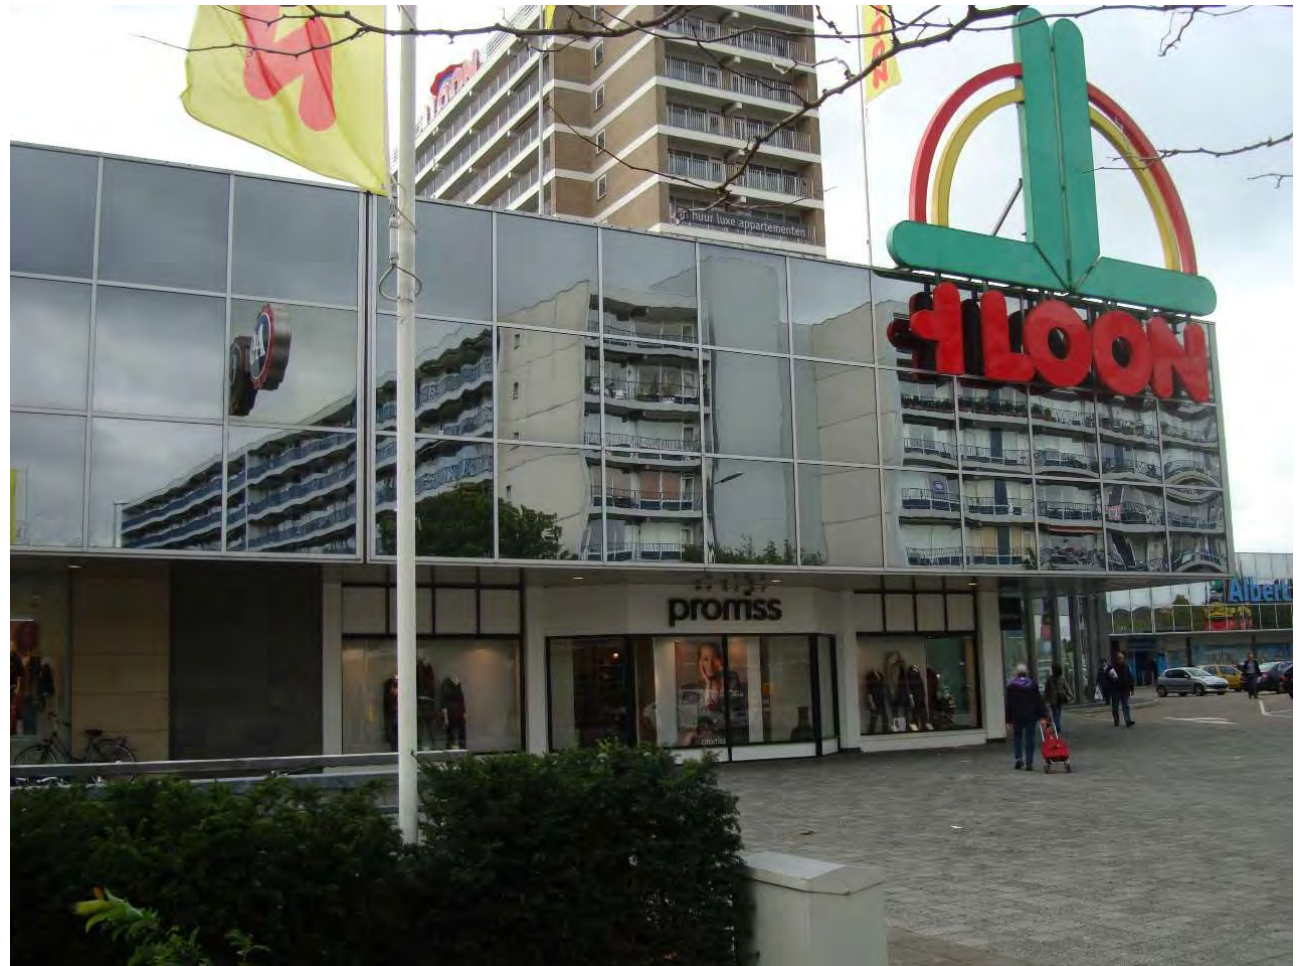
Signals shown before sinkhole shopping centre 't Loon, sept. 2011 Heerlen

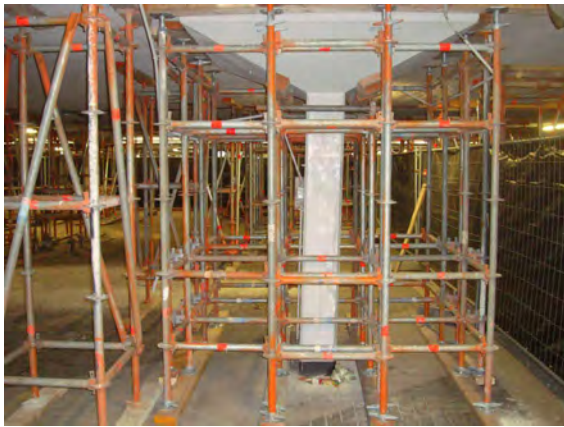
Analyzing signals before sinkhole 't Loon, sept. 2011 Heerlen

Inclined pillars in garage

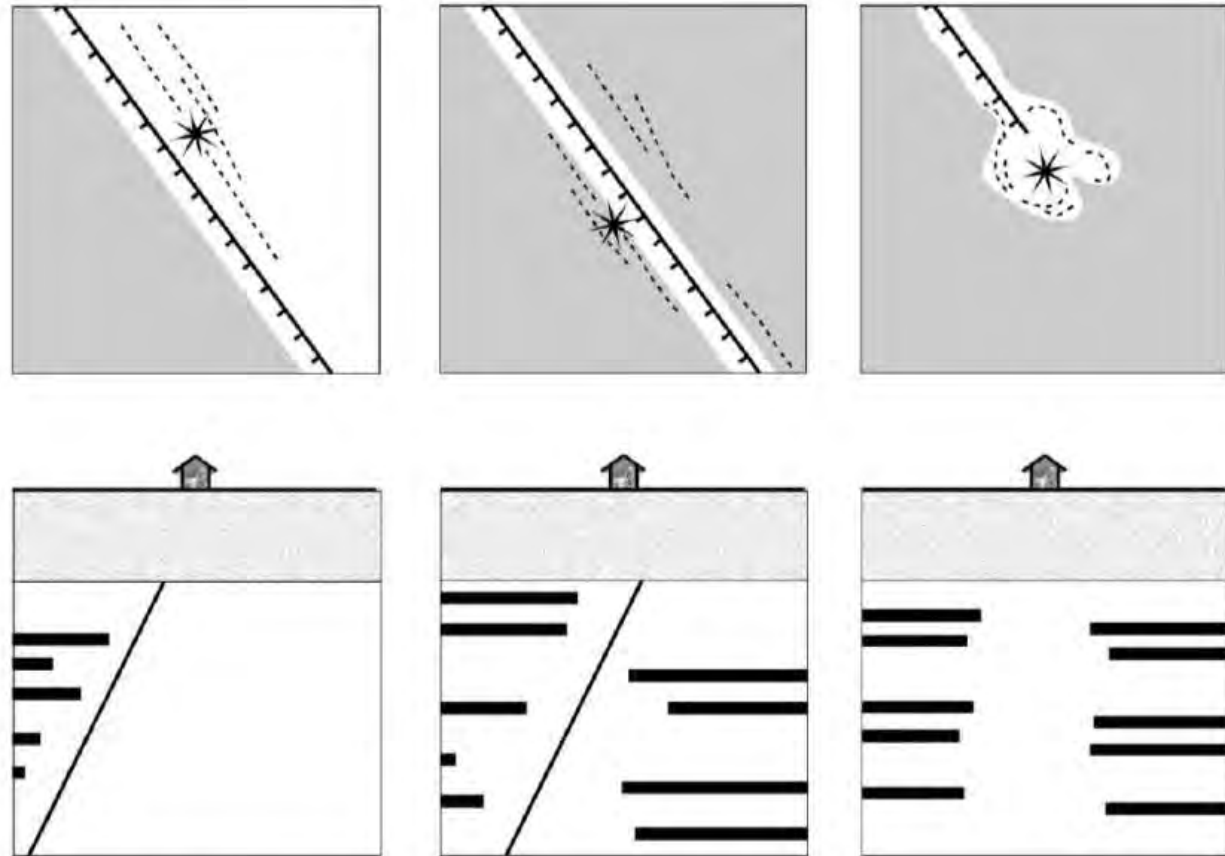
Figure 7: Three characteristic mining situations: one-sided mining (left), two-sided mining with a linear pillar in between (middle), and mining around a (quasi-) circular pillar (right).

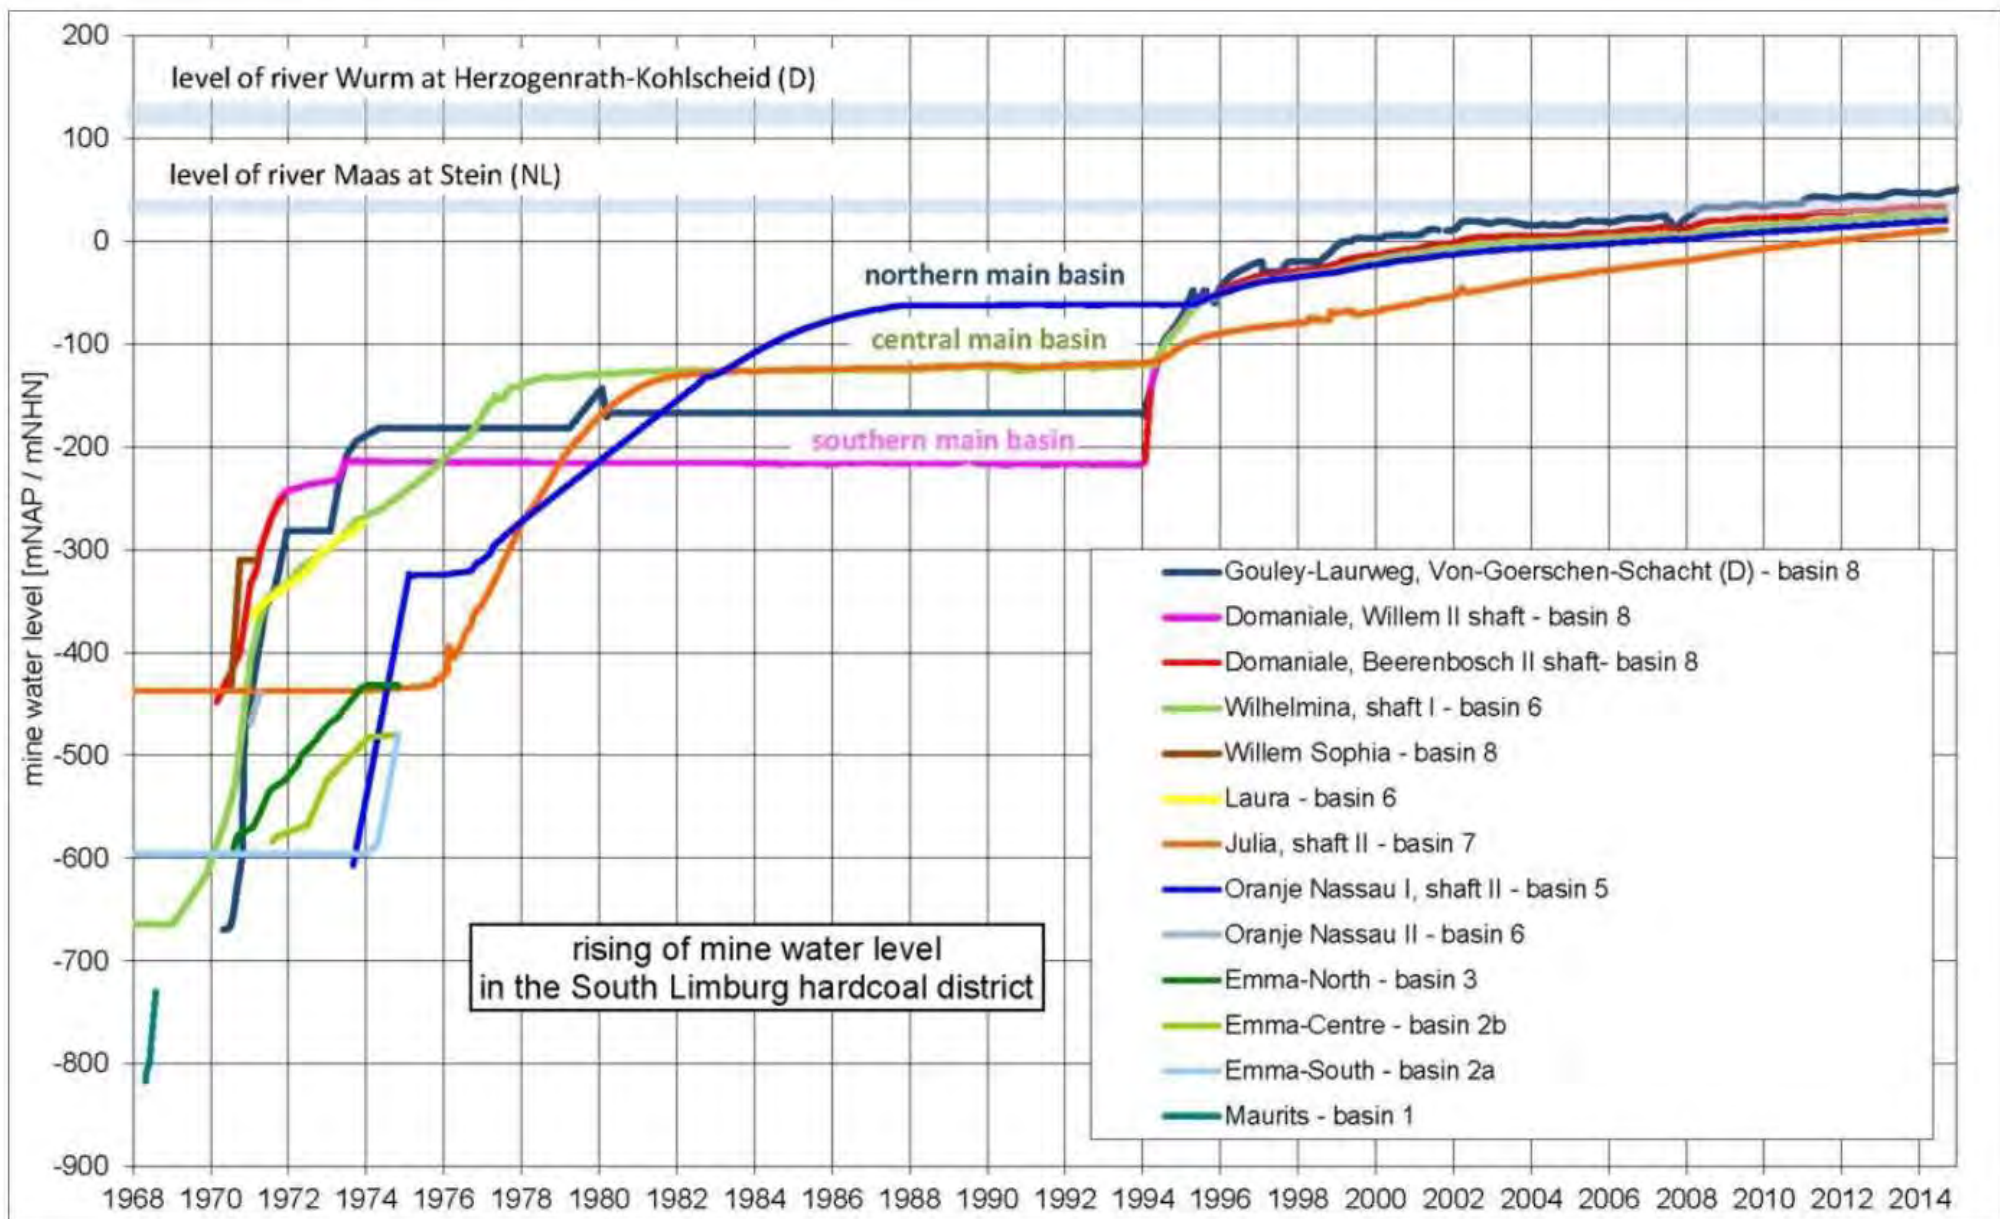
Fig. 21: Rising mine water levels in the South Limburg hard coal district

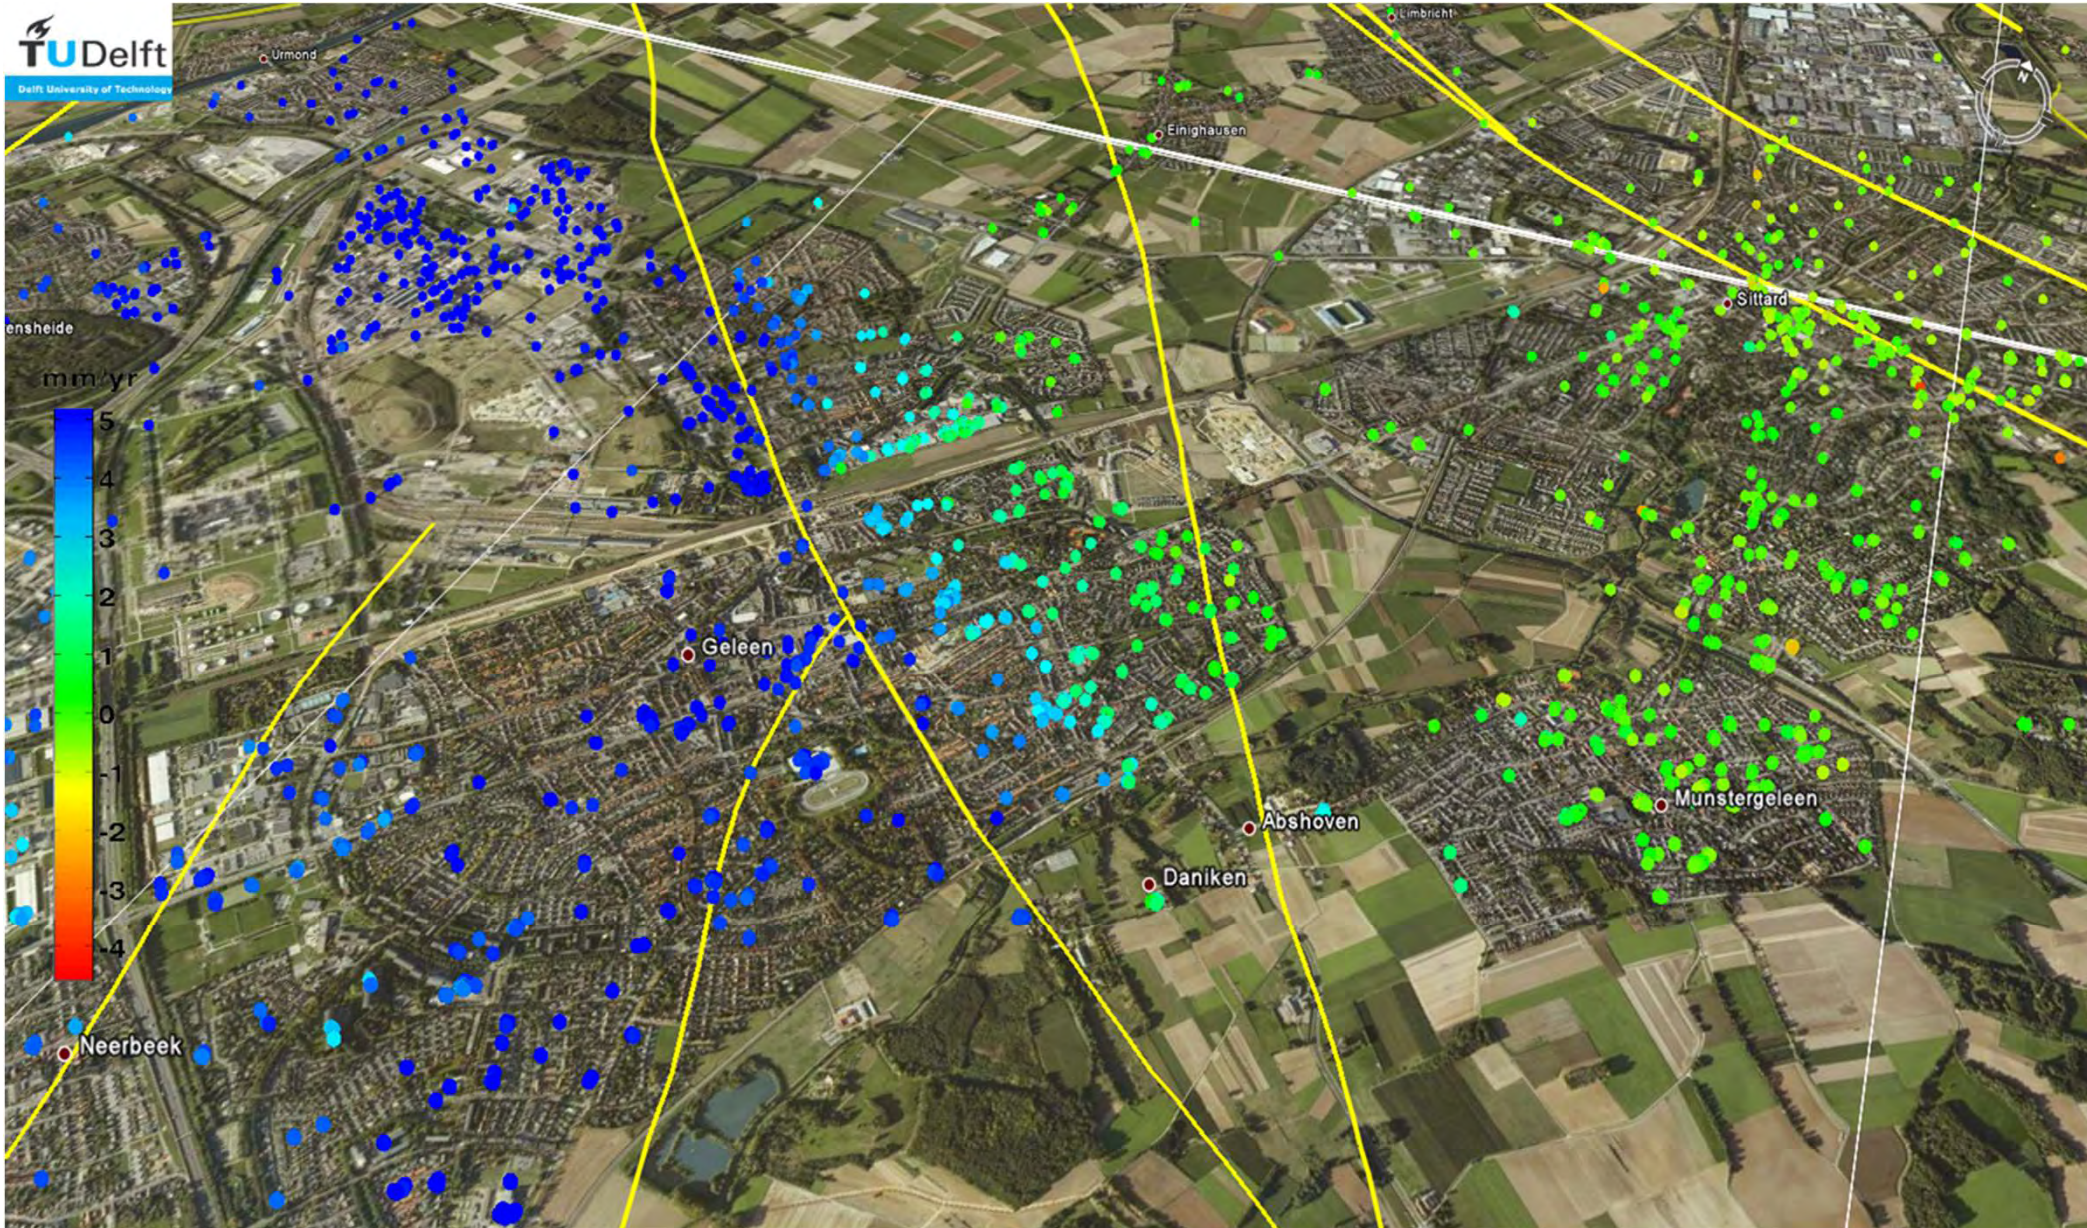
InSAR picture with differential movements Heerlerheide breuk (TU Delft)

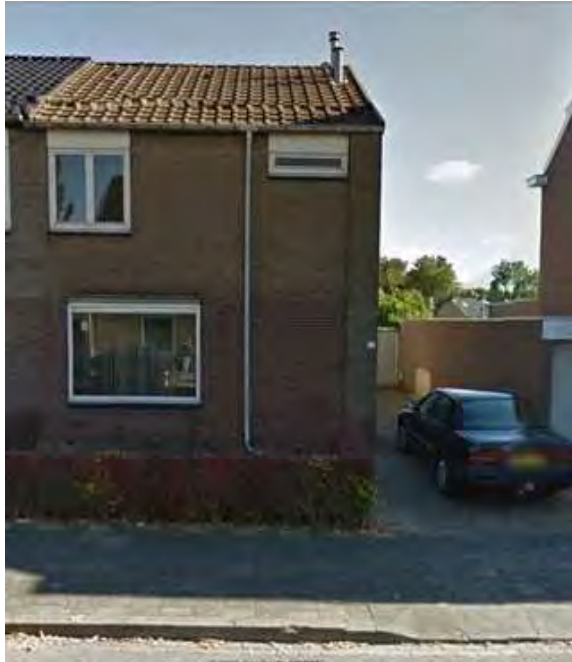
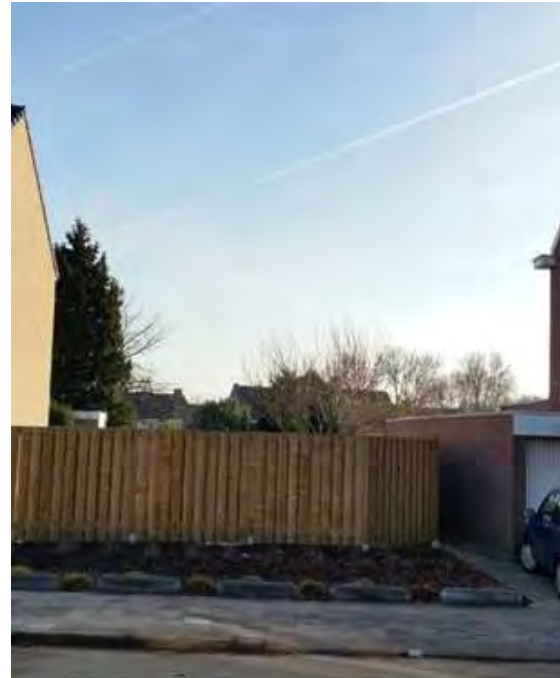
However, sometimes damage did occur e.g. in a house a few meters from an old 'step' ...
Finally the house is demolished (right picture)

Small sinkhole of a few m³ did develop close to another old 'step', about 50 m away

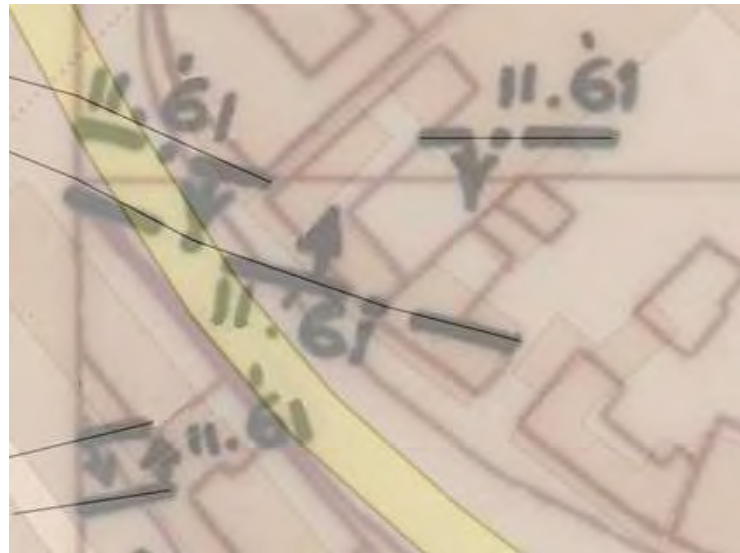
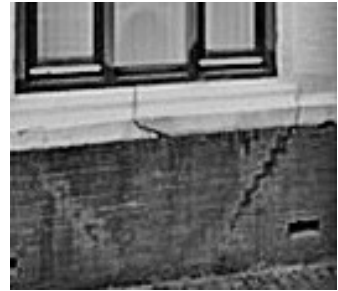
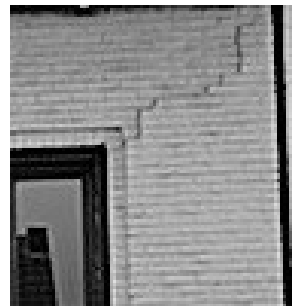
Examples of (old ?) damage near steps/small grabens

Pay more attention to signals of settlement/damage close to old 'steps' in extension zones.

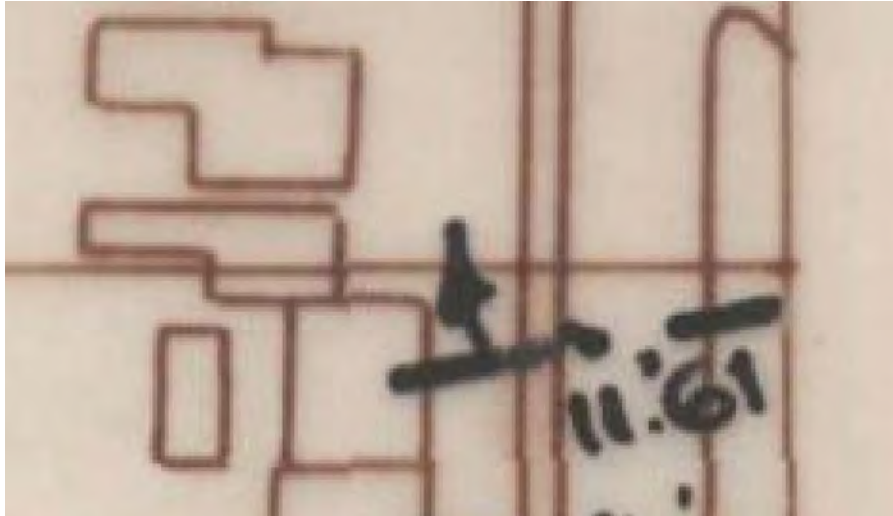
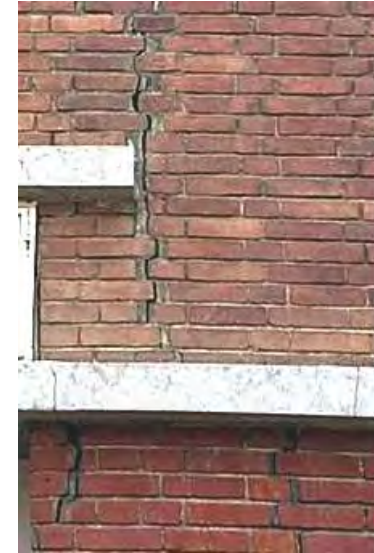
Hypotheses:

1. (Reactivation of) old steps ?
2. Differential settlements ?
3. Water inflow and material transport in small graben/steps?

Observations near a 'step' in Brunssum during drilling operation (a.o. fluid losses)

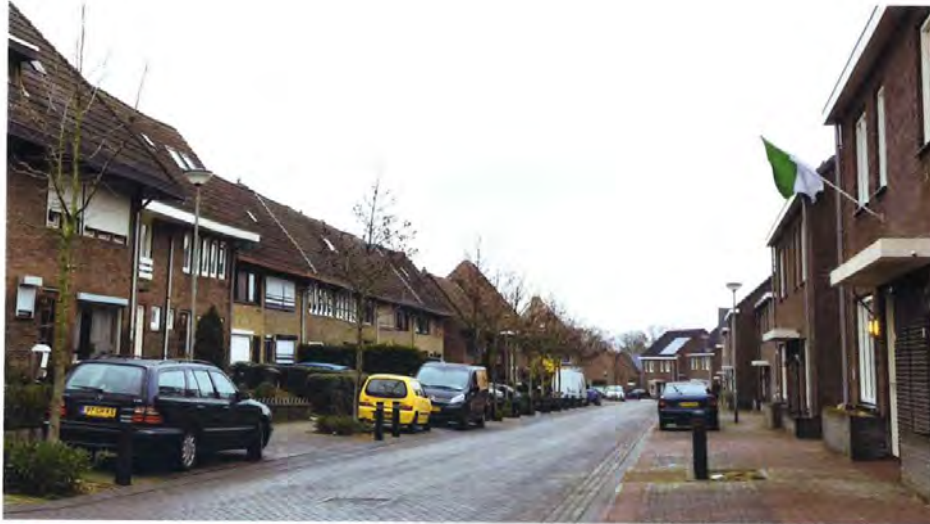
De Gulikstraat, zo te zien een doorgewone straat in een woonwijk. Links in het midden het blok van acht woningen dat opgekocht en gesloopt moet worden. Rechts nieuwbouw met goede fundering.

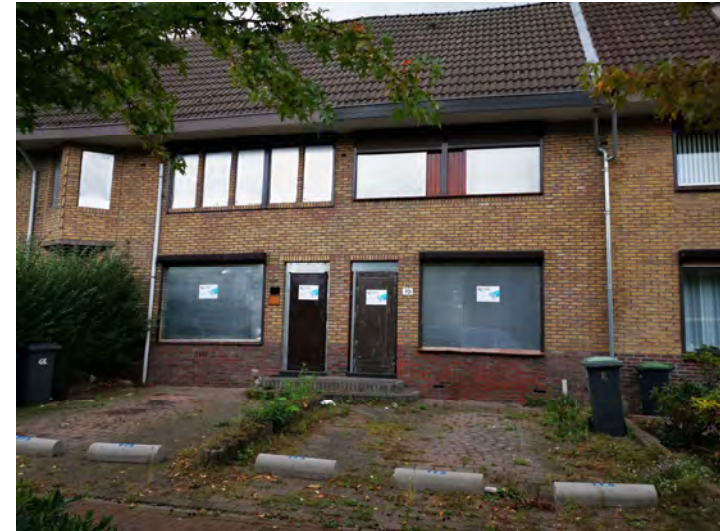
Vanwege ernstige mijnschade en vrijwel zeker te verwachten toekomstige schade worden acht woningen in de Gulikstraat in de wijk Op de Bossen in Eygelshoven (Kerkrade) opgekocht en gesloopt. Een primeur in Limburg.

Newspaper article about Gulikstraat in Eygelshoven-Kerkrade (Feldbiss-fault)
